## Lake : SOWL KERE

### Audit observations

### Saul Kere in 2002

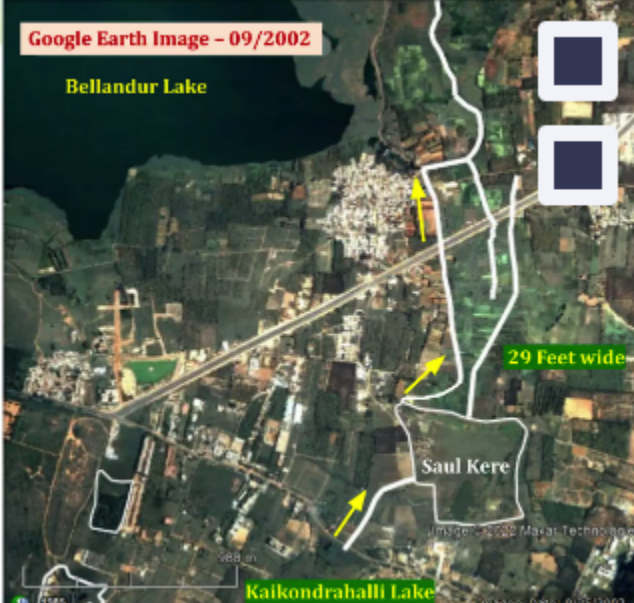
Google Earth Image - 09/2002

- Map shows the presence of two outlets (White Line) downstream of the Saul Kere through the command area.
- Yellow arrows represent the water flow direction.
- 1. **Waste weir Outlet** – North west corner of the Lake
- 2. **Sluice Gate Outlet** – From the north side of the Lake (center of the Lake Bund)
- These Kaluves were measured on Google earth to be approx 29 feet wide (as wide as Primary Kaluve or Raja Kaluve)

29 Feet wide

The command area has been heavily built on, and the outlet channels of the lake have been blocked, altered in direction and size , as can be seen from the two pics above,

This is specifically pertinent at the Eco Space junction....resulting in surrounding and upstream flooding.
